Bushkill Creek Trout Redd Survey

Forks of the Delaware Trout Unlimited

2017 Bushkill Creek Trout Redd Survey

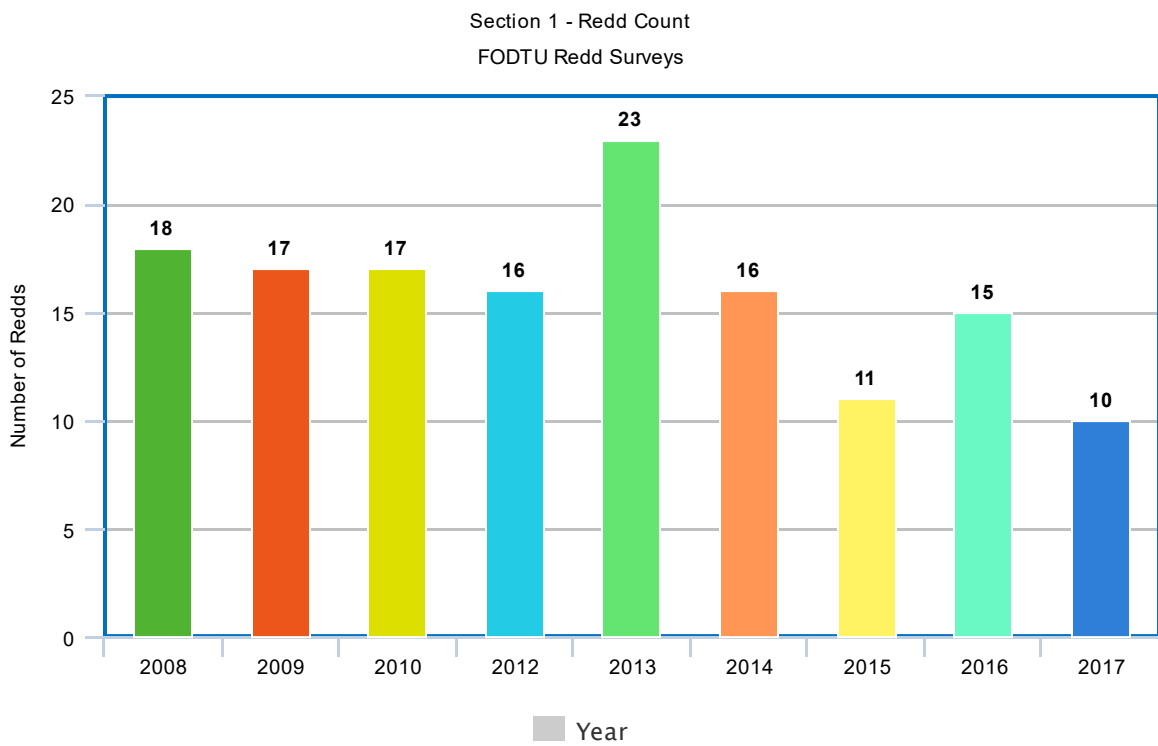
2017 Bushkill Creek Trout Redd Survey-Section 1 (Stocker Mill Rd to Newlins Mill Rd)		
GPS Coordinates	# of redds	Location description
N 40° 43.743' W 075° 14.854'	1	Newlins Bridge
N 40° 43.702' W 075° 14.941'	1	Side channel
N 40° 43.689' W 075° 14.940'	1	
N 40° 43.662' W 075° 14.984'	1	Bushkill Creek Estates
N 40° 43.365' W 075° 14.788'	3	Above Penns Grant bridge
N 40° 43.332' W 075° 14.777'	1	Below Penns Grant bridge
N 40° 43.180' W 075° 14.701'	1	Gas line
N 40° 43.146' W 075° 14.700'	1	Zucksville Road
Total redds (field count)	10

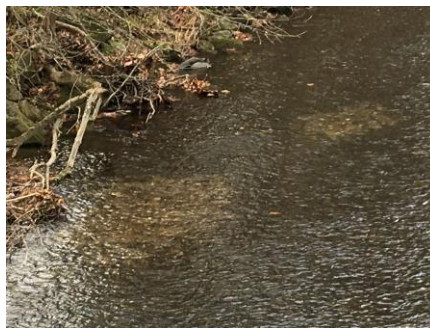
Redds in Section 2 above Penn's Grant Bridge

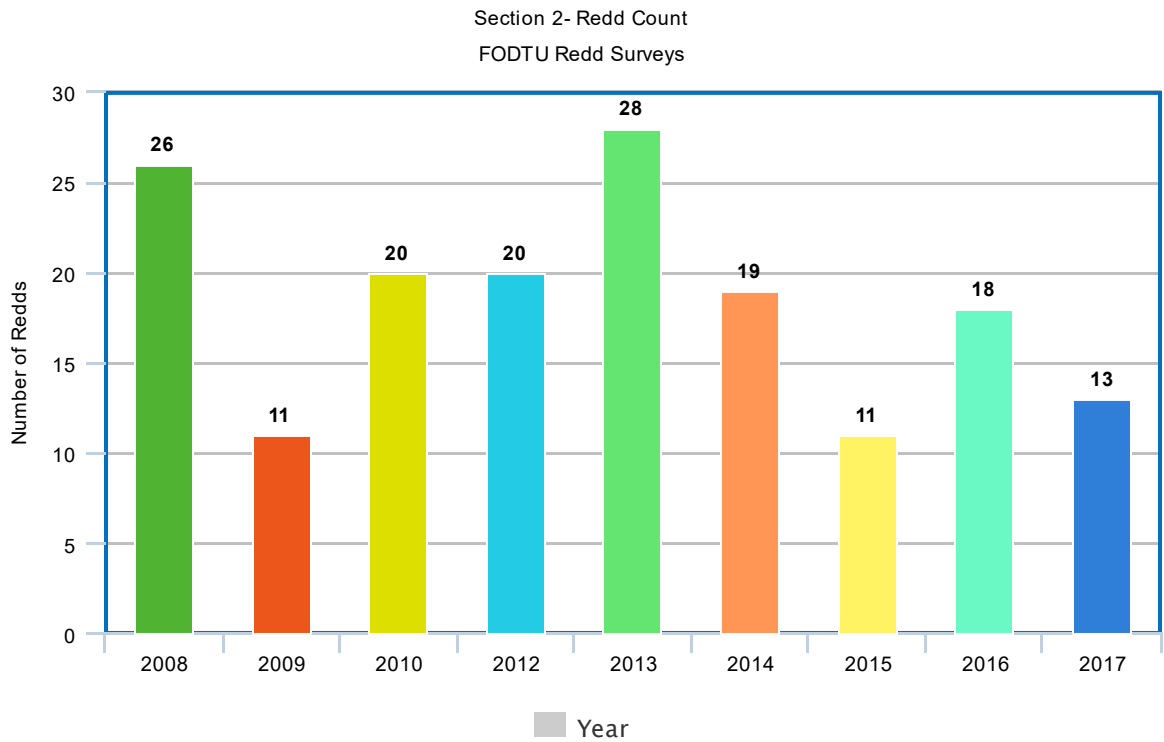
2017 Bushkill Creek Trout Redd Survey-Section 2 (GJ Mills entrance to Edgewood Avenue)		
GPS Coordinates	# of redds	Location description
N 40° 43.037' W 075° 14.754'	2	Below Edgewood Avenue bridge
N 40° 43.037' W 075° 14.754'	1	Tail of Edgewood Avenue bridge pool
N 40° 42.001' W 075° 14.350'	1	End of Crayola building
N 40° 42.064' W 075° 14.304'	6	Tail of meadow pool, mid-stream
N 40° 42.072' W 075° 14.306'	2	Extreme tail out of meadow pool
N 40° 42.091' W 075° 14.211'	1	
Total redds (field count)	13

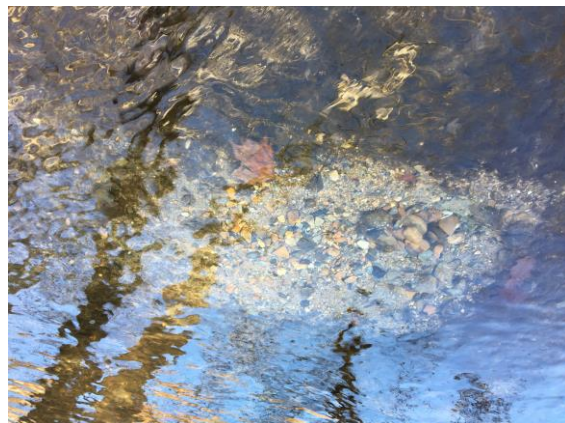
Redd located in Section 2 even with end of Crayola Buildi

Redd located in Section 2 at end of Crayola Building

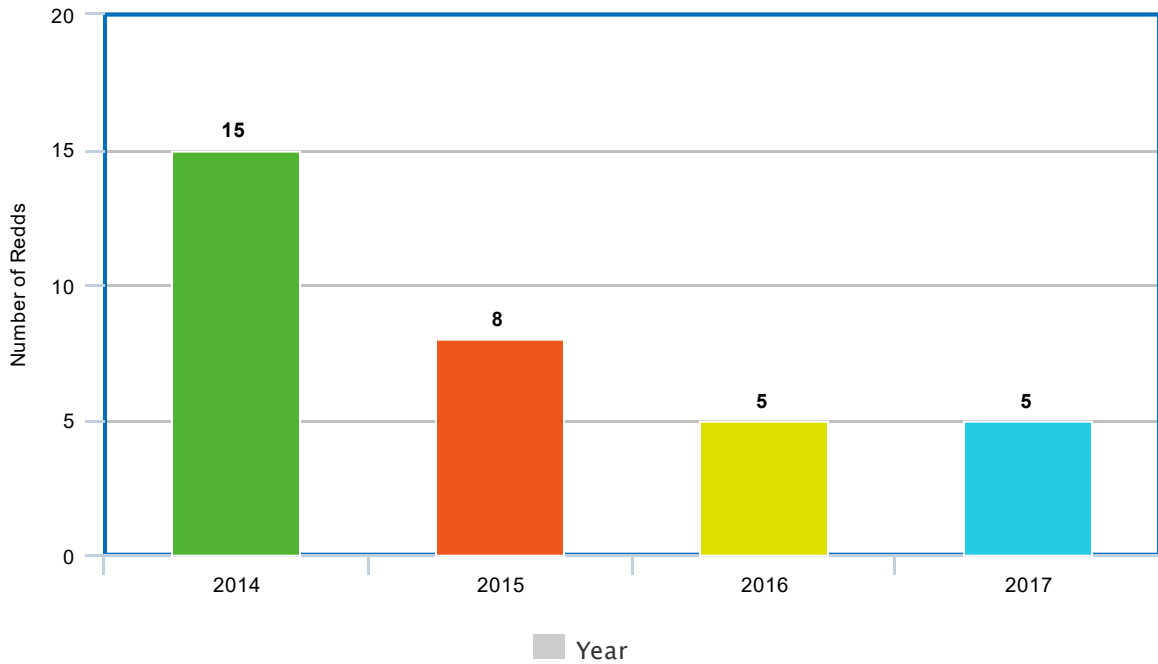
Section 3 - Redd Count
FODTU Redd Surveys

2017 Bushkill Creek Trout Redd Survey-Section 3 (Newlins Mill Rd. to Bushkill St., Tatamy)		
GPS Coordinates	# of redds	Location description
N 40° 44.129' W 075° 14.784'	1	Braids below Spring House pool
N 40° 43.881' W 075° 14.627'	1	
N 40° 43.857' W 075° 14.637'	1	
N 40° 43.790' W 075° 14.632'	1	
N 40° 43.735' W 075° 14.787'	1	
Total redds (field count)	5

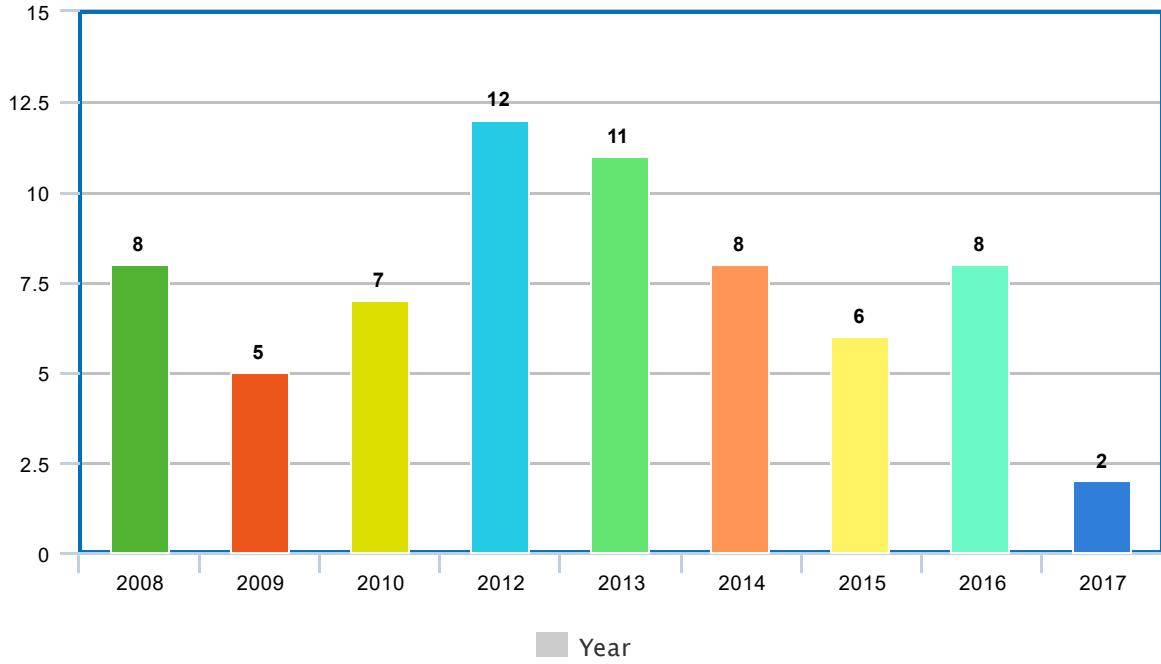
Section 1 - Subsection (Stocker dam to Stocker Mill Bridge) Redd count
FODTU Redd Surveys

- Section 1 had nominal redd production in the past significant spawning site from the gas line to Zucksville Road. Also, no redds were observed at Stocker Mill Bridge. The following chart depicts redd production over time for the subsection (Stocker dam to Stocker Mill Bridge). Total number of redds for Section 1 was the lowest since doing the survey. Is this indicative of a downward trend in redd production in Section 1 or just a cyclical variation? The area above and below Penn's Grant Bridge (upstream from the dam) was utilized again this year and would be considered the significant spawning site (40% of the redds) for Section 1 in 2017.

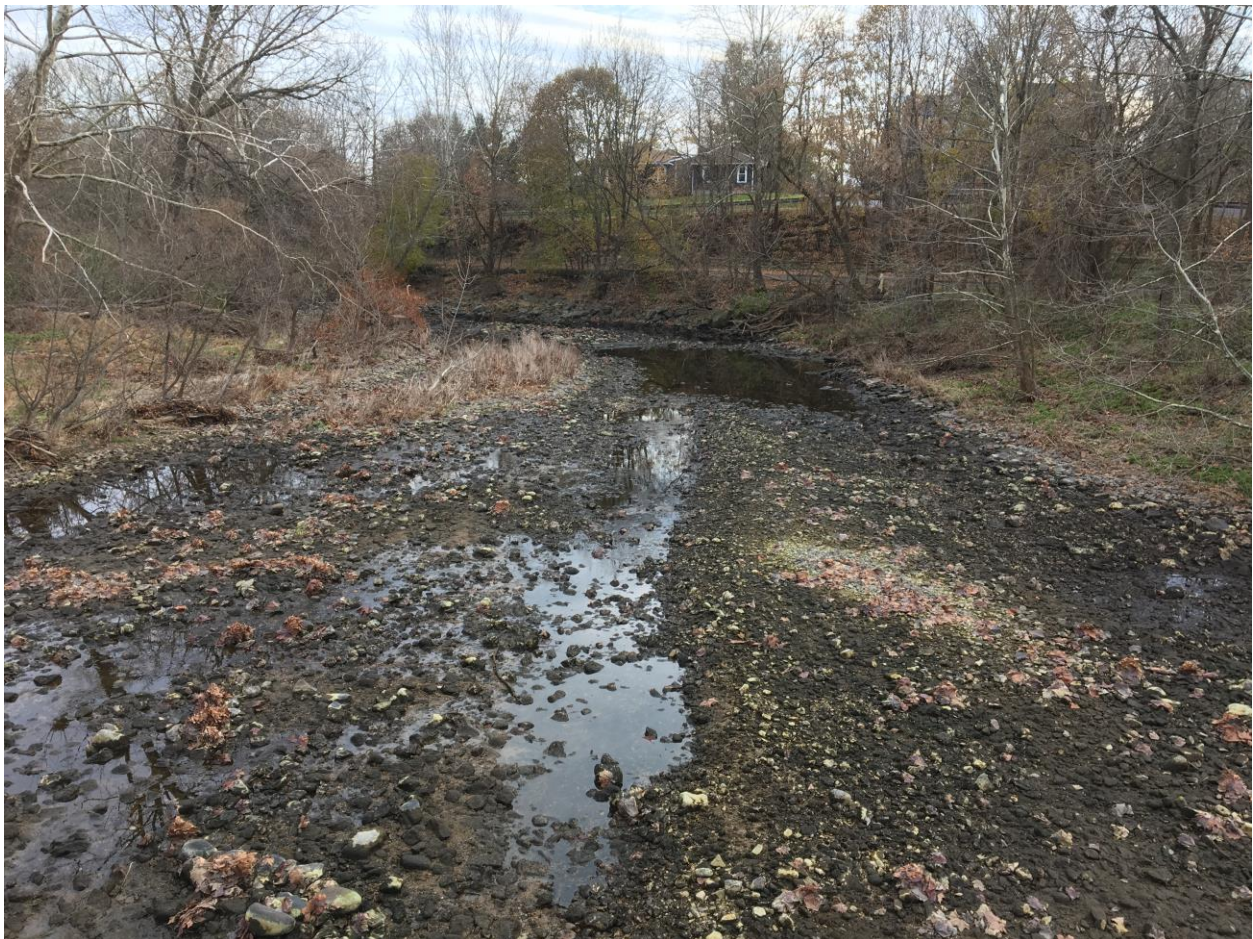
- Section 3 has the most potential to be impacted by low flows. Low flow conditions like on November 25th due to PPL maintenance resulting in Buzzi Unicem extended pump shutdown expose the trout to increased predation from herons and other fish eaters and jeopardizes the redds. I observed a bald eagle flying upstream of the Tatamy spring house during the low flow conditions on November 25th. The lack of productivity for the third straight year may just be due to a dwindling number of trout utilizing this reach due to environmental factors.
- In analyzing the various charts, there is some concern that the amount of redds is trending down, but it will take more data to fully understand if this is truly a trend or just cyclical in nature.

Low flow conditions like on November 25th strand and suffocate fish, expose them to predation and endanger the trout redds that require flowing oxygenated water. Photo taken from Main Street in Tatamy, upstream from Survey Section 3.

- Educate the public about the importance of naturally reproducing wild trout and their role in a functioning ecosystem.
- Identify solutions to the dewatering of the Bushkill Creek in Tatamy.
